**O & M INSPECTION REPORT
FOR NAVIGATION AND SHORE PROTECTION PROJECTS**

1. Project Name: Hilo Deep Draft Harbor

2. Date of Inspection: May 3, 2004

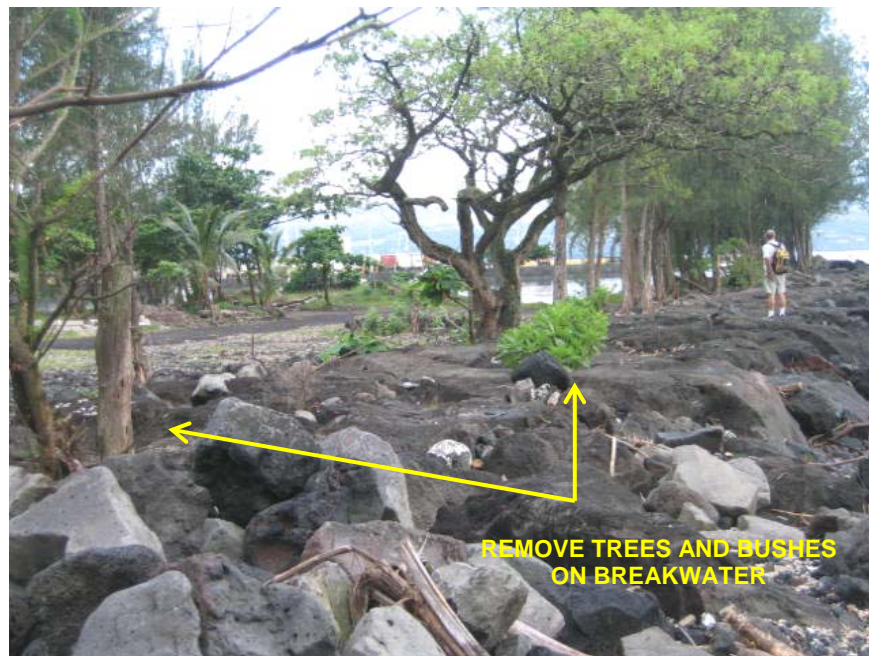
P2. Sta. 0+50 – Sta. 0+70, Vegetation, remove perched armor stones resting on crest.

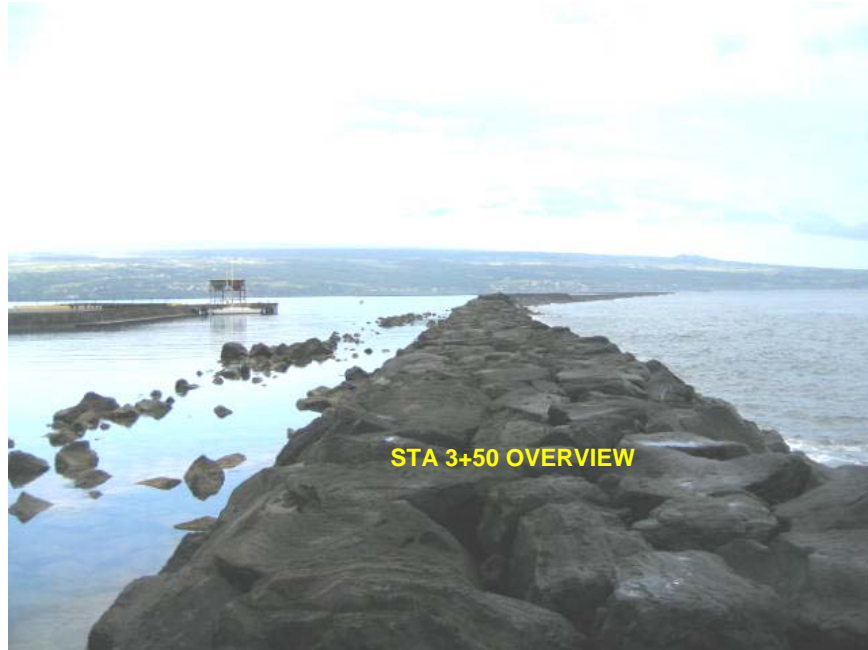
P3. Sta. 3+50, Overview

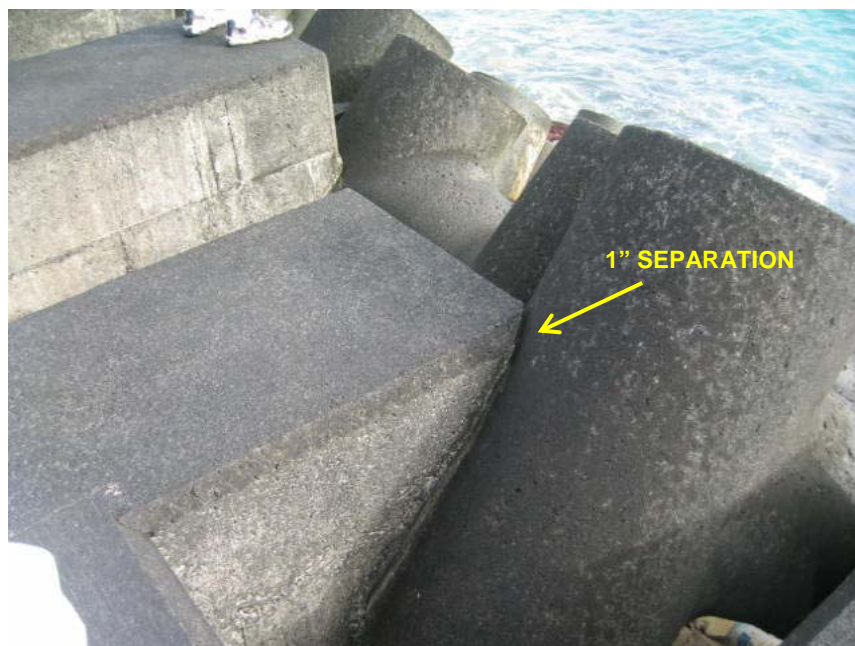
P8. Sta. 11+15, OS 1" separation (tribar #727)

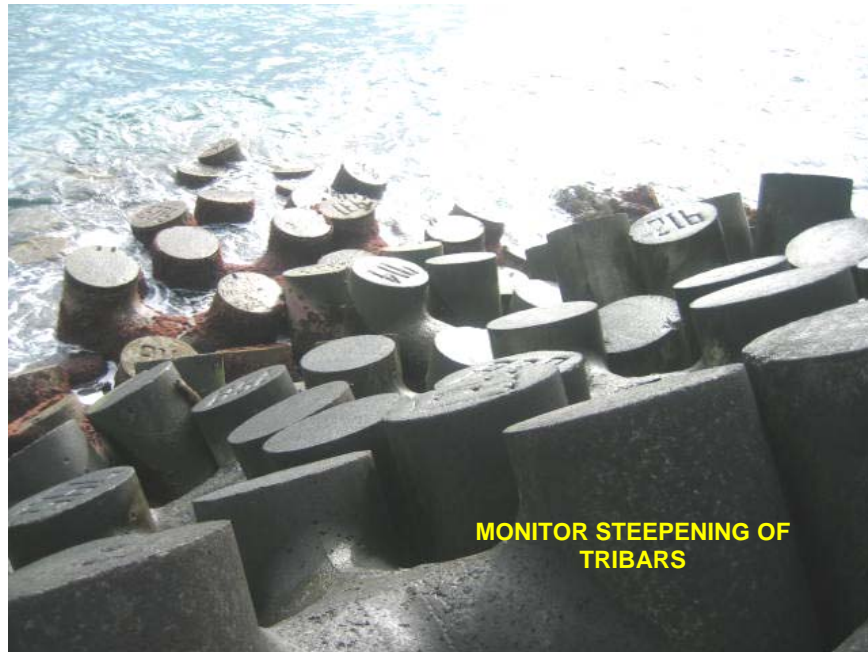
P9. Sta 11+15, OS, Monitor tribar movement.

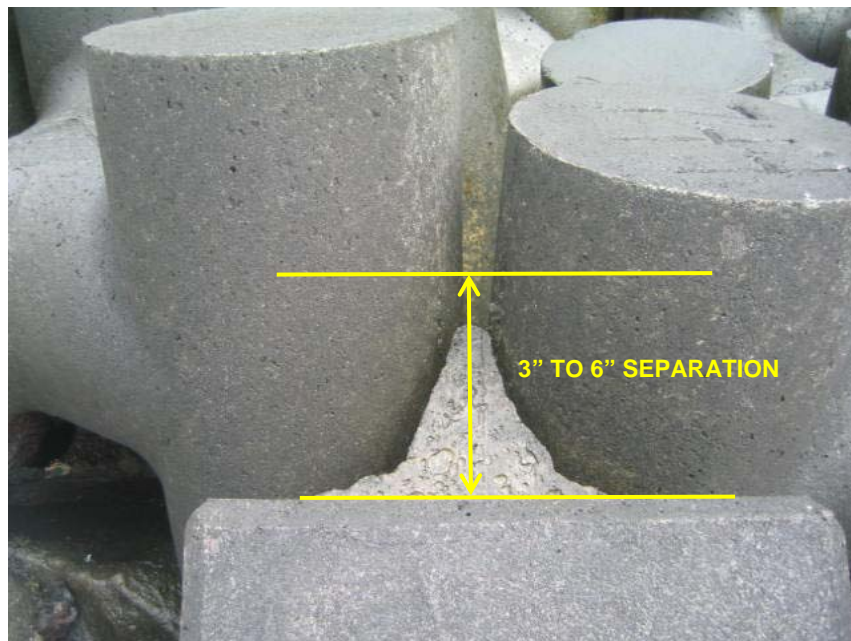
P10. Sta. 11+25, OS, 3-6" separation (tribar #740 and #744)

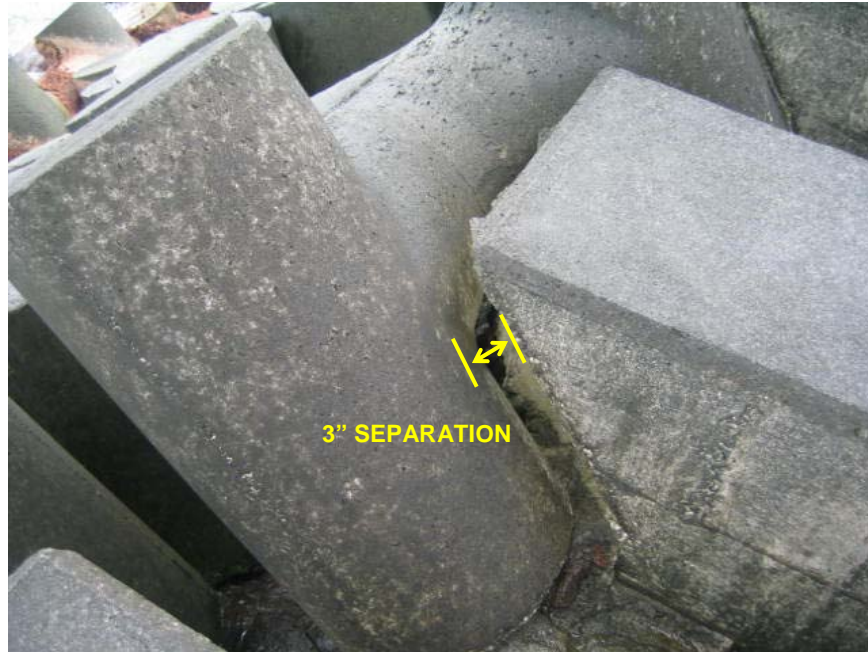
P11. Sta. 11+35, OS, 3" separation (tribar #851). Sideslope steepening.

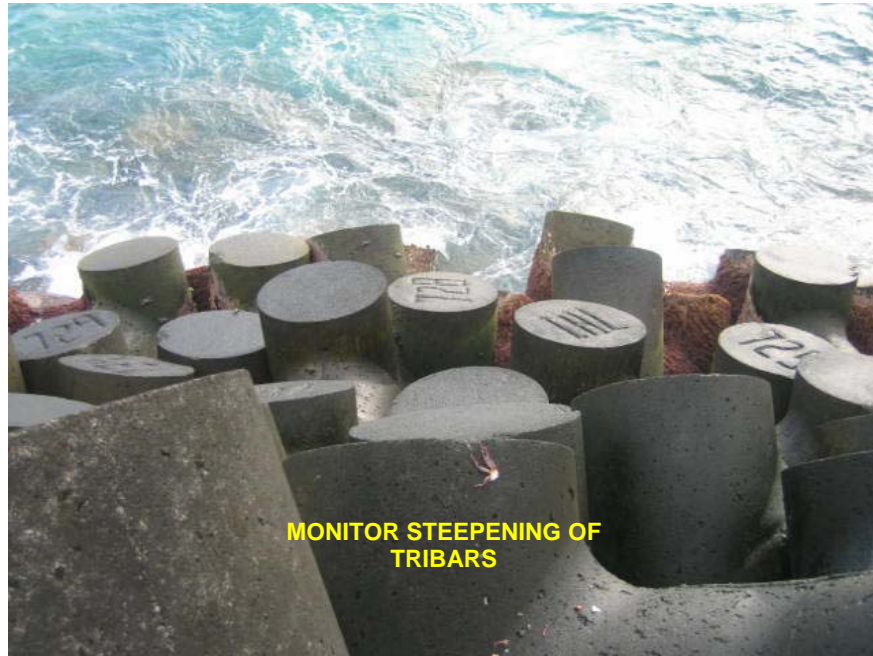
P13. Sta. 11+75, OS, Monitor tribar movement.

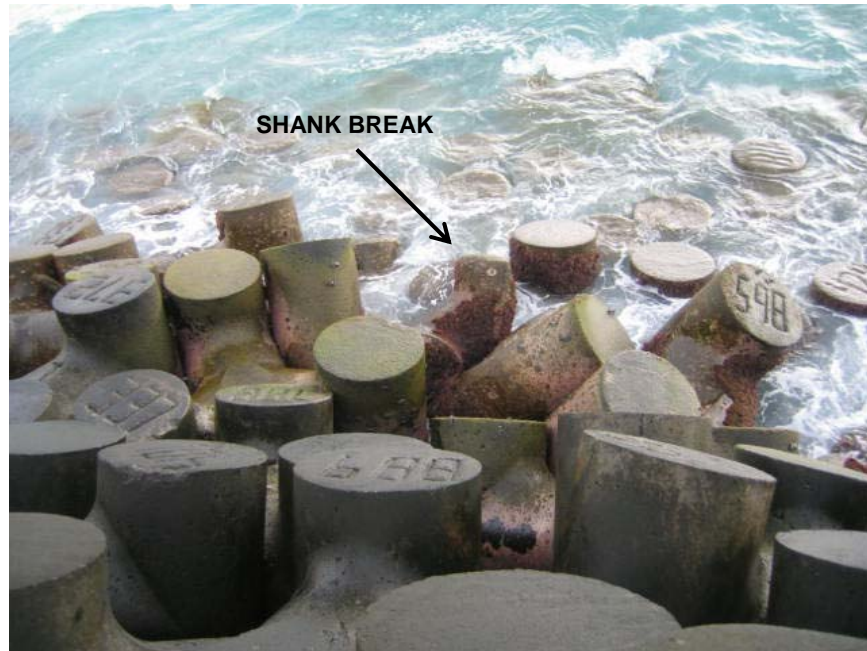
P19. Sta.15+98, OS, Monitor shank break at water line.

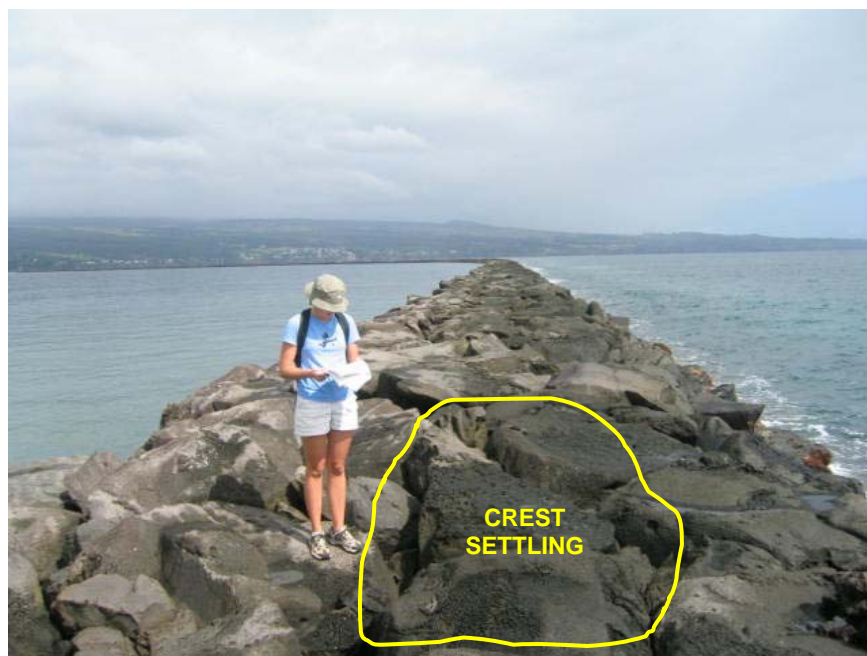
P32. Sta. 28+54, Settling at centerline of crest

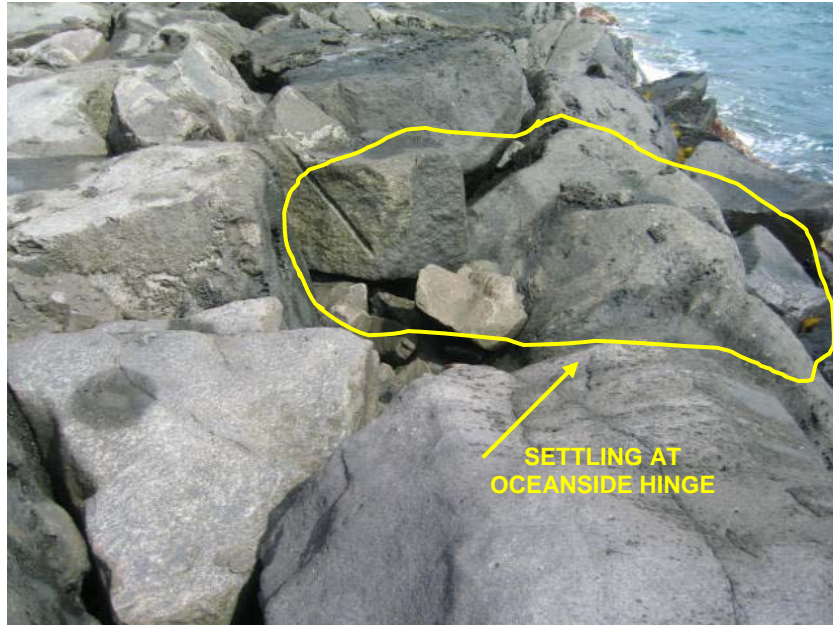
P33. Sta. 28+78, OS, Settling at hinge/sideslope

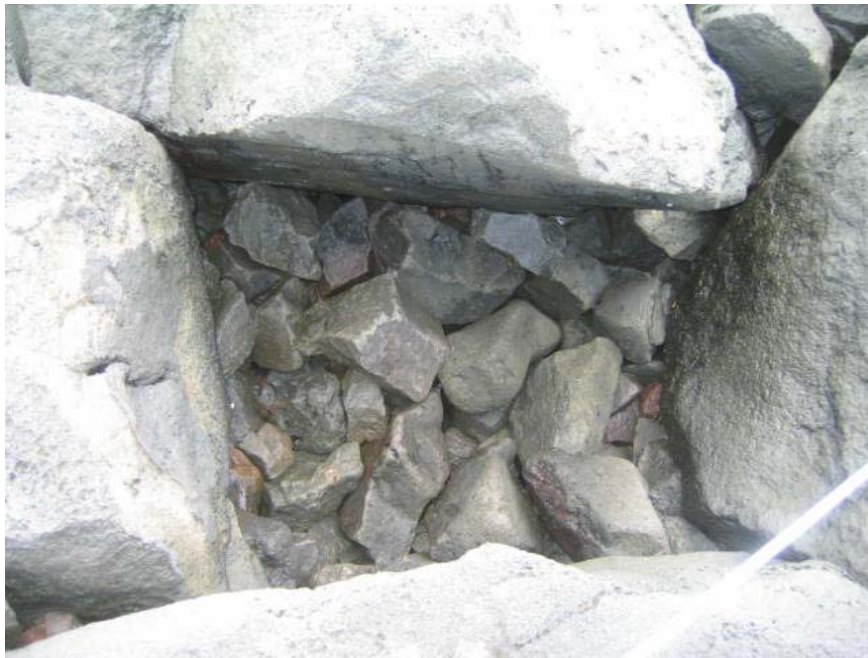
P36. Sta. 33+66, Void on crest

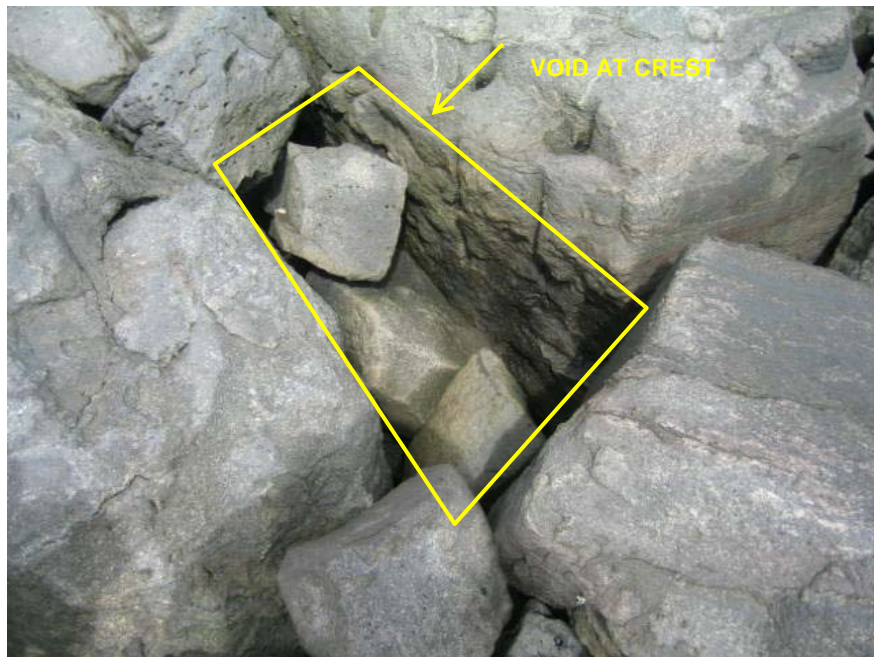
P38. Sta. 35+84, 3'x 4' void at crest, UL exposed.

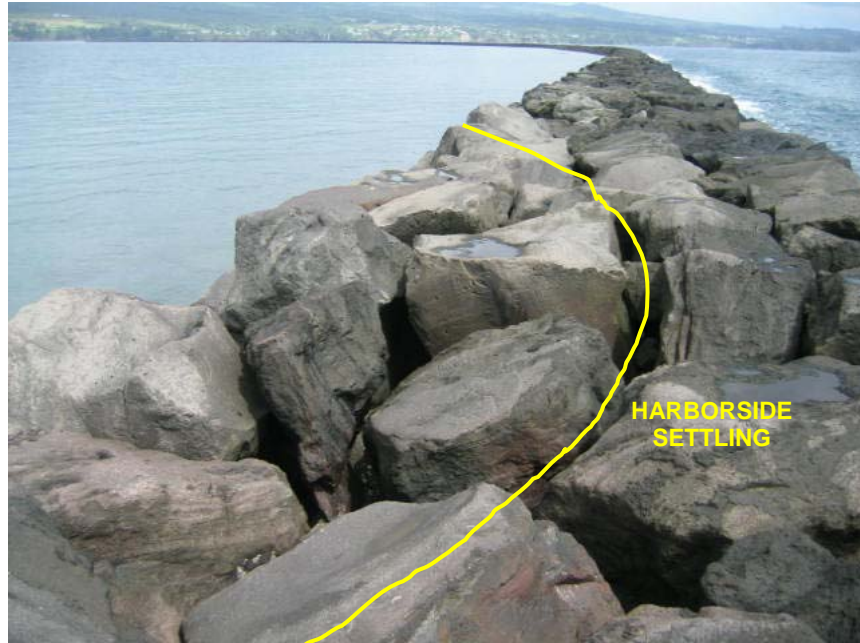
P39. Sta. 36+10, 50% of crest on harborside settled ~ 5ft

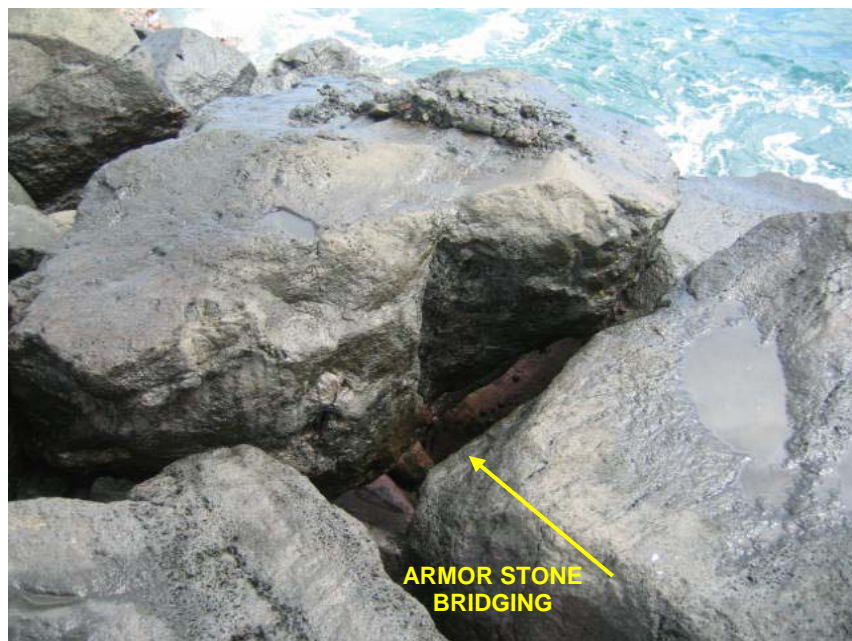
P40. Sta. 37+25, OS, Bridging armor stone.

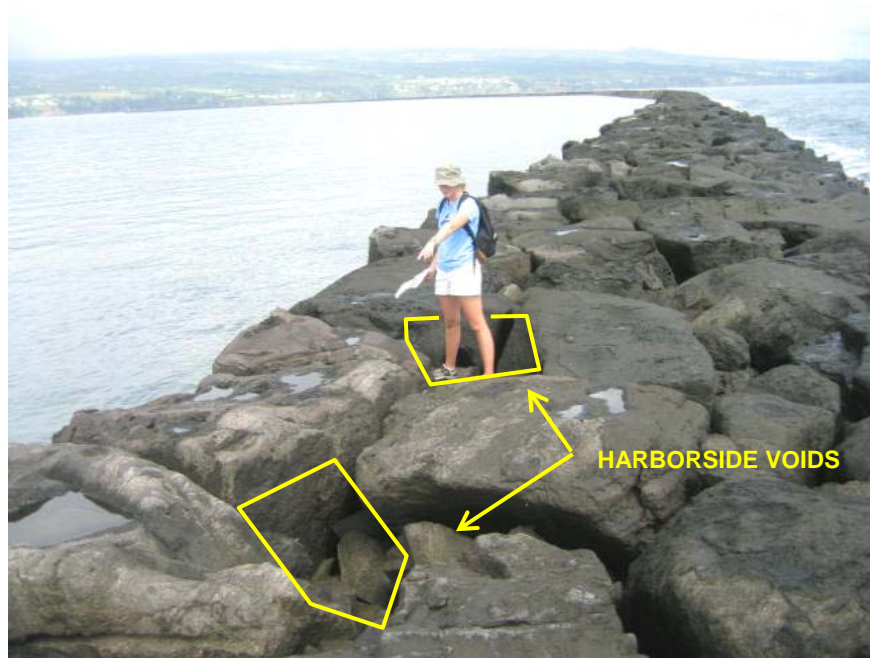
P41. Sta. 37+25, Settling at crest, two HS voids.

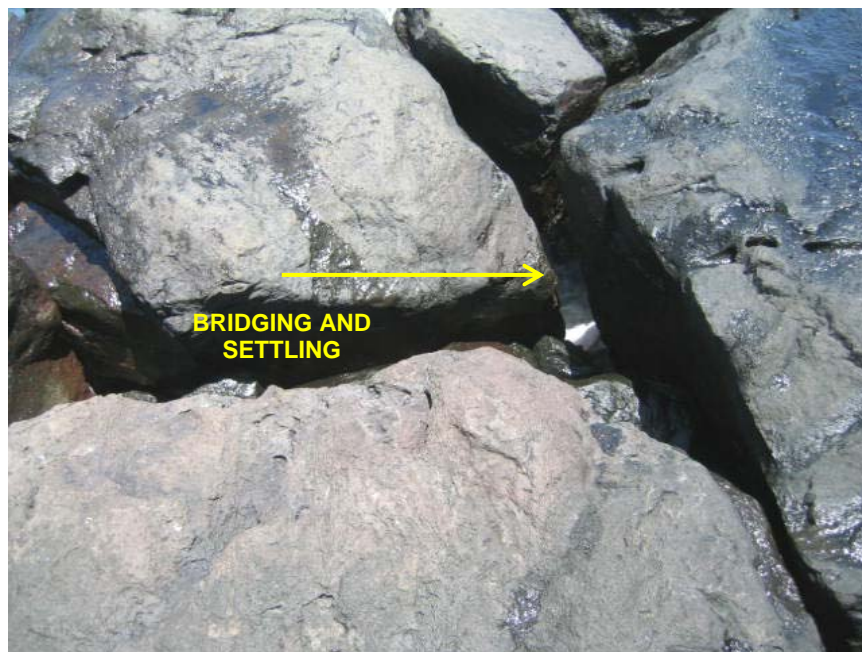
P64. Sta 65+00, Bridging and settling on oceanside slope

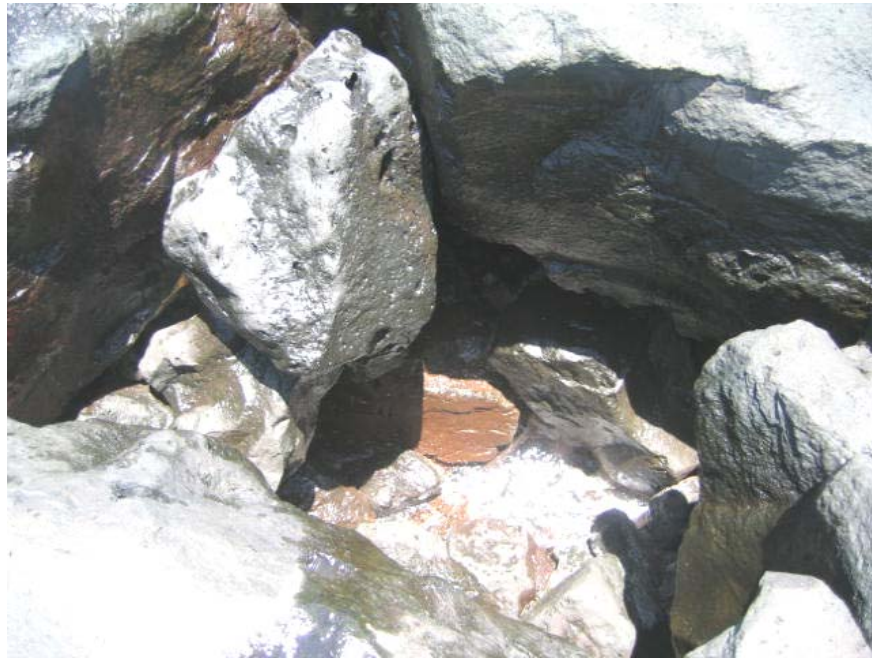
P69. Sta 69+98, HS, 3'x4' void extending 10' down to waterline

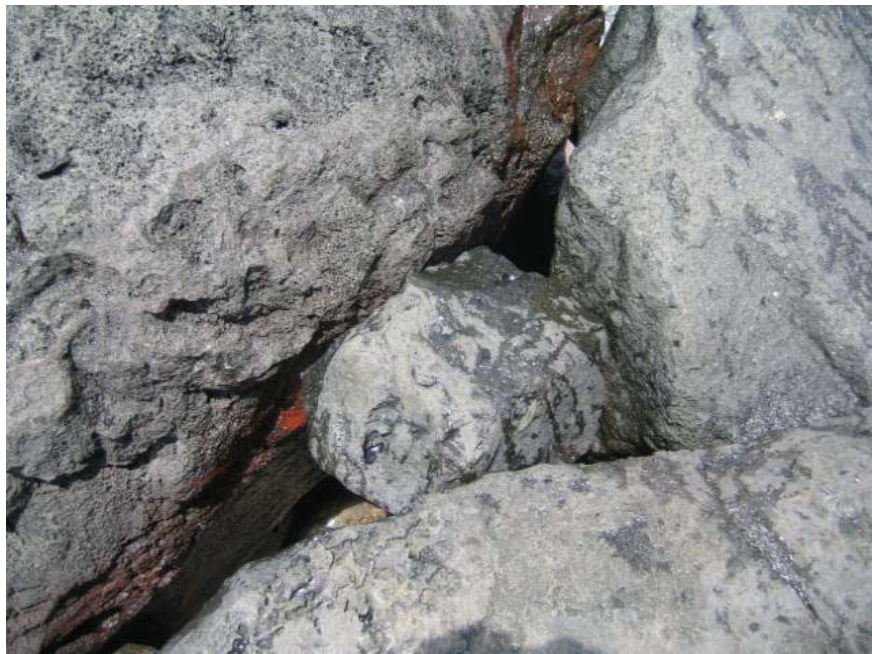
P76. Sta. 78+80, OS, Bridging at hinge
